# NATIONAL TRANSPORTATION SAFETY BOARD

## PIPELINE ACCIDENT REPORT

PHILADELPHIA GAS WORKS  
NATURAL GAS PIPELINE RUPTURE,  
EXPLOSION, AND FIRE  
PHILADELPHIA, PENNSYLVANIA  
MAY 11, 1979

NTSB-PAR-79-3

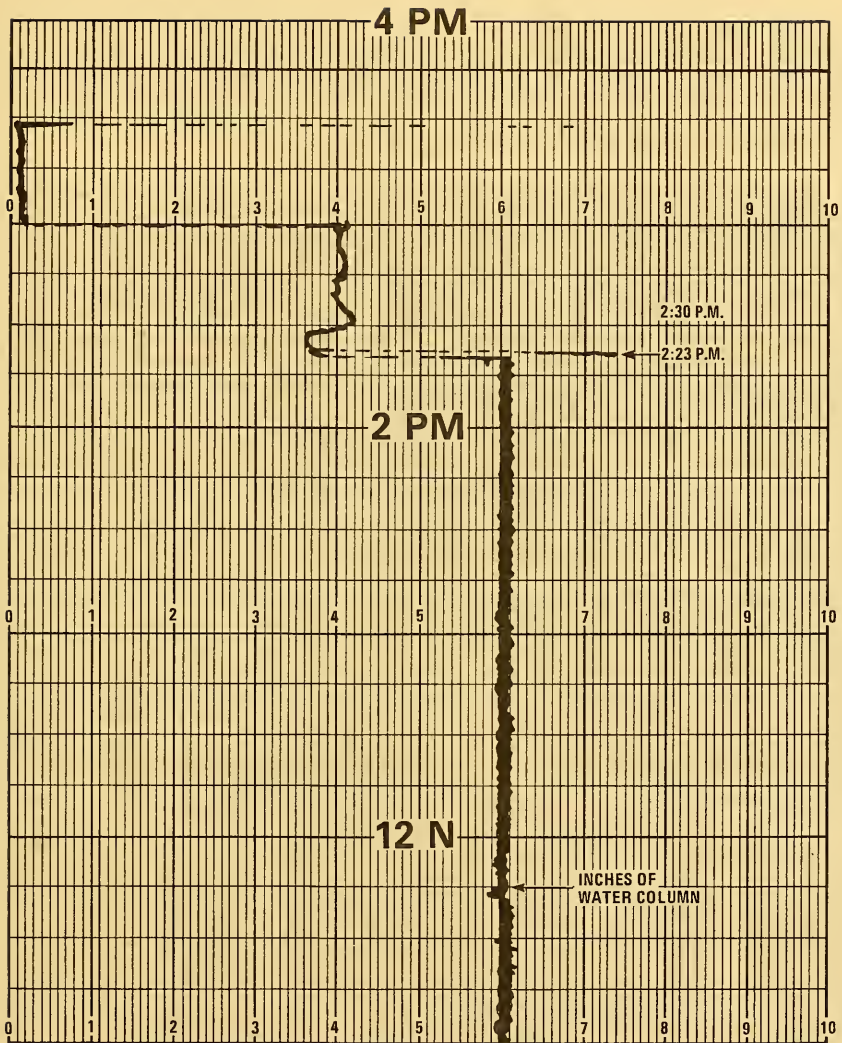
Figure 2. Pressure-recording strip chart.

At 2:30 p.m., a gas pressure recorder which was connected to the gas system that ran under Margaret Street, and located 1 1/2 blocks from the intersection, indicated that the pressure had dropped from 6 to 3.6 inches of water column. (See figure 2.) This information was telemetered into the PGW distribution department dispatcher office where an alarm sounded. A pressure specialist was dispatched to the location 1 1/2 blocks from the accident site. He checked the pressure chart which indicated a failure somewhere on the gas main. The chart showed the pressure drop in inches of water column and the time of the drop in pressure. The pressure-recording chart was found to be 7 minutes slow, which meant that the indicated 2:23 p.m. pressure drop actually occurred at 2:30 p.m. While the specialist was checking out the equipment, the explosion occurred.

been noticed, and the pressure-recording chart 1 1/2 blocks away had been constant in the recent past. Therefore, the Safety Board concludes that the gas main collapsed at 2:30 p.m. on May 11, 1979, as indicated by the rapid drop from 6 to 3.6 inches water column shown on the pressure-recording chart.

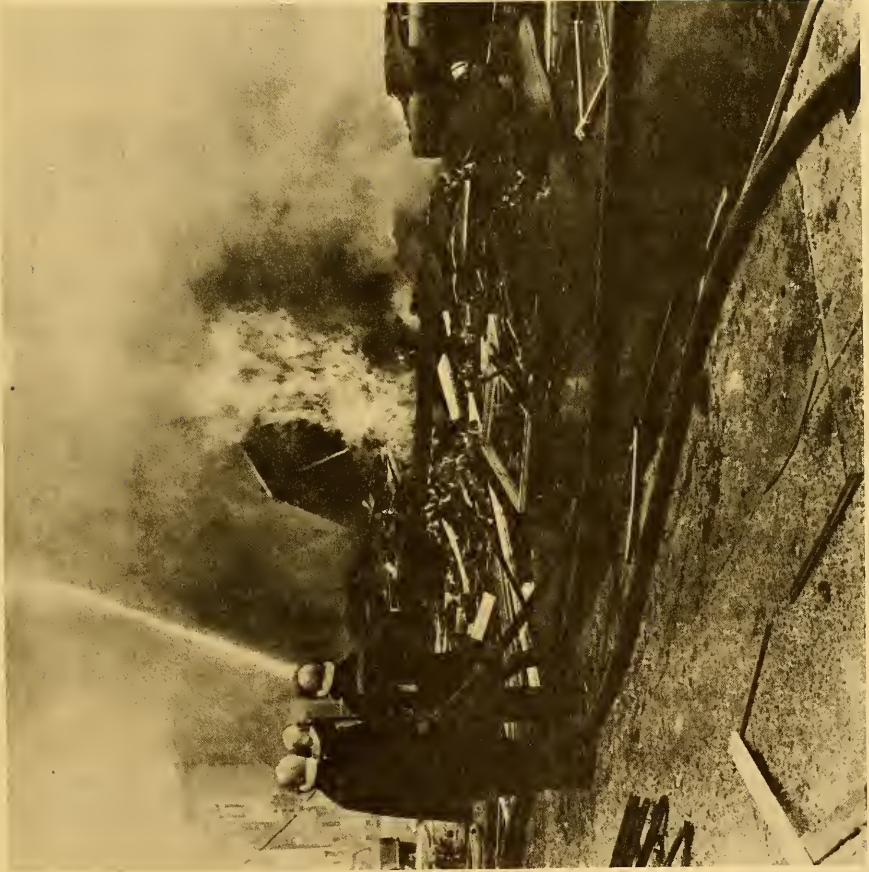
Figure 3. Firefighters controlling the fire in debris of buildings at 4701 and 4703 Tacony Street.

The fire was intense, fueled by escaping natural gas and the dry timber of the old buildings. Firefighters did not use all of the fire hoses available to extinguish the fire immediately because they did not want to cause anyone trapped in the rubble to be drowned. The fire was not extinguished until 4:50 p.m. when the flow of gas was shut off.

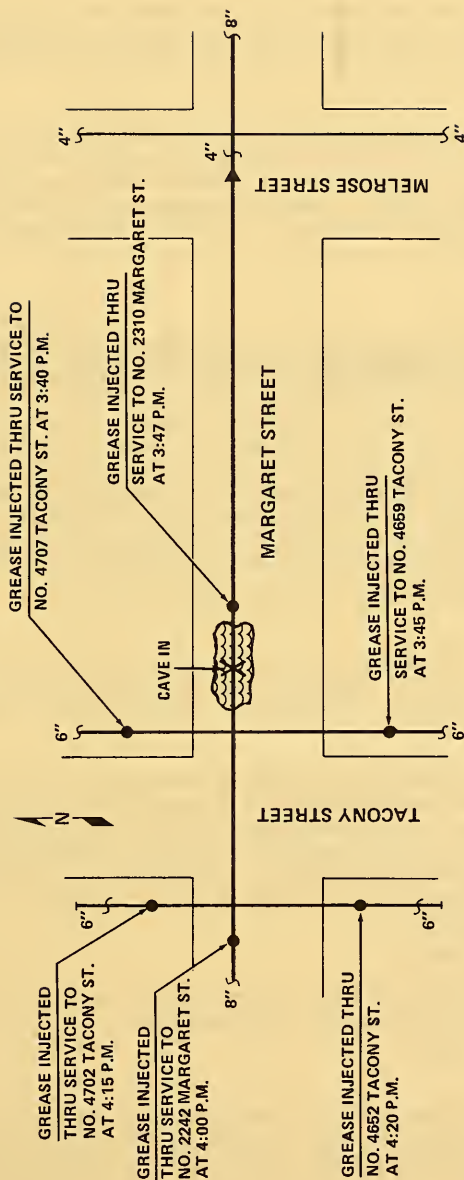
Figure 4. Grease injection locations.

At 7:30 p.m., while the search for survivors continued, PGW customer service crews continued the gas odor survey of all houses near the accident site. At 9:45 p.m., the PGW distribution crew completed cutting and capping all natural gas mains leading to the intersection. Six "greased off" locations were capped. (See figure 4.)

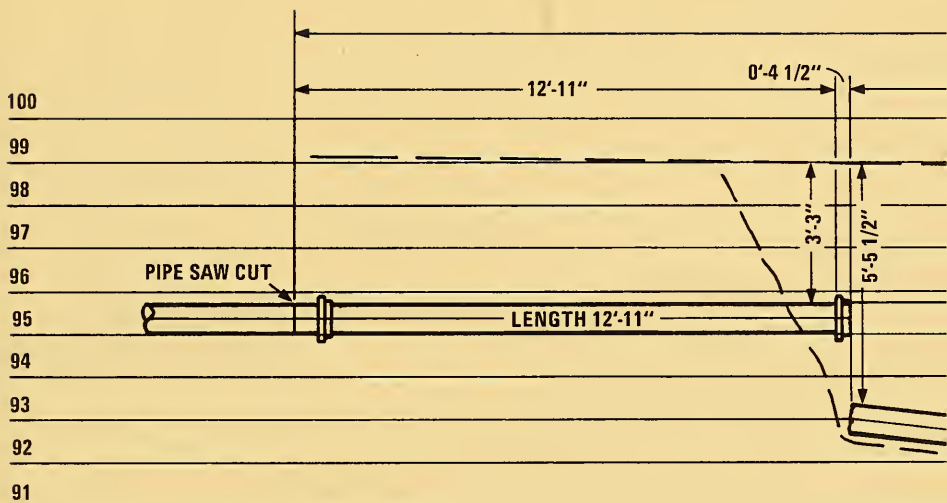
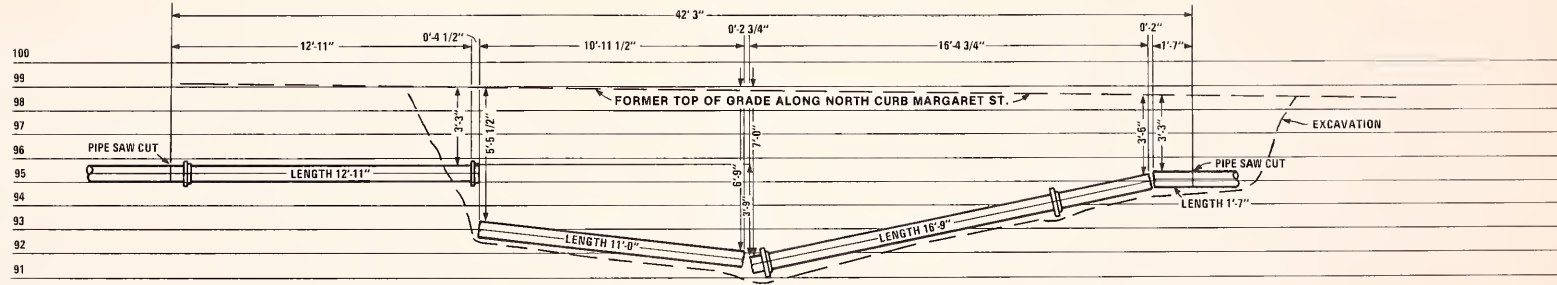
**FIGURE 5.**  
**PROFILE VIEW LOOKING NORTH 8" CAST IRON GAS MAIN**  
**ELEVATIONS TAKEN 5-12-79**

When the hole was cleared of debris and the water was pumped out, investigators found that the 8-inch, cast-iron gas main below the street was broken in three places. (See figure 5—Profile.)

When the gas main was uncovered, the pipe to the east was lying at a slight angle from the horizontal. Excavation to the west exposed two breaks in the line, one end of this broken section was 3 feet 9 inches below its former horizontal position. (See figure 5—Profile.) Further excavation to the west revealed a third break about 11 feet west of the second break. The gas main had shifted laterally a total of 1.325 feet from its original position. (See figure 5—Plan View.) The broken main ends and segments of the water main were cut off and visually examined by a Safety Board metallurgist. The pipe was also sent to the National Bureau of Standards for further metallurgical examination.

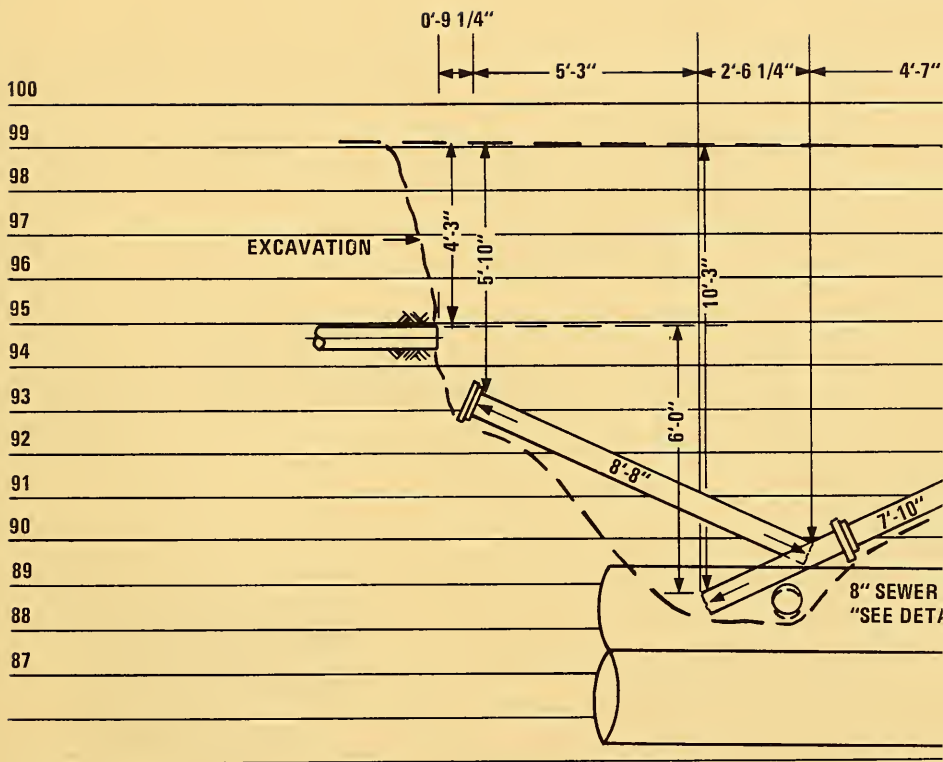
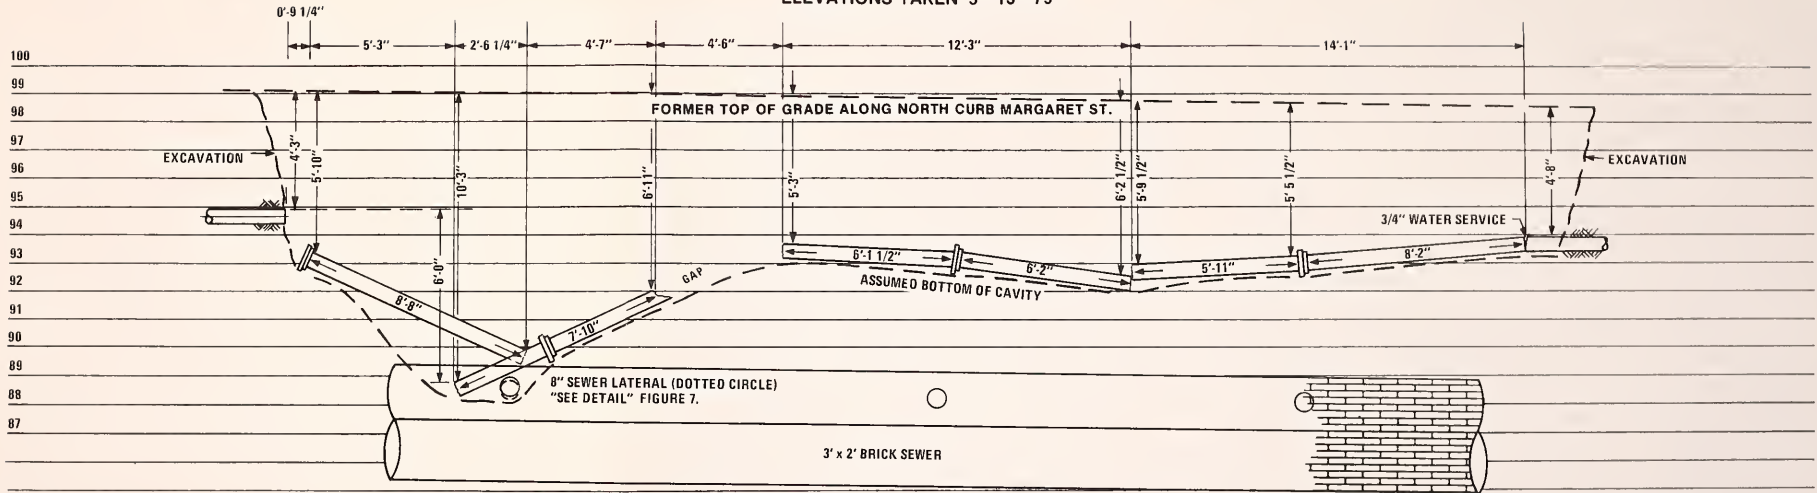
**FIGURE 6.**  
**PROFILE VIEW LOOKING NORTH 6" WATER & 3' x 2' SEWER**  
**ELEVATIONS TAKEN 5-13-79**

A 6-inch, cast-iron water main in the hole was broken in five places. (See figure 6.) The water main had been installed in 1941 with 4 feet 3 inches of cover. The deepest break in the water main occurred where the main crossed above an 8-inch sewer lateral from a rowhouse. At this point one end of the broken main had dropped 6 feet below its original horizontal position, and had severed the 8-inch sewer lateral connection with the sewer main. (See figures 6 and 7.) The oval-shaped, 3-foot by 2-foot brick sewer was very old, but was found to be intact in the

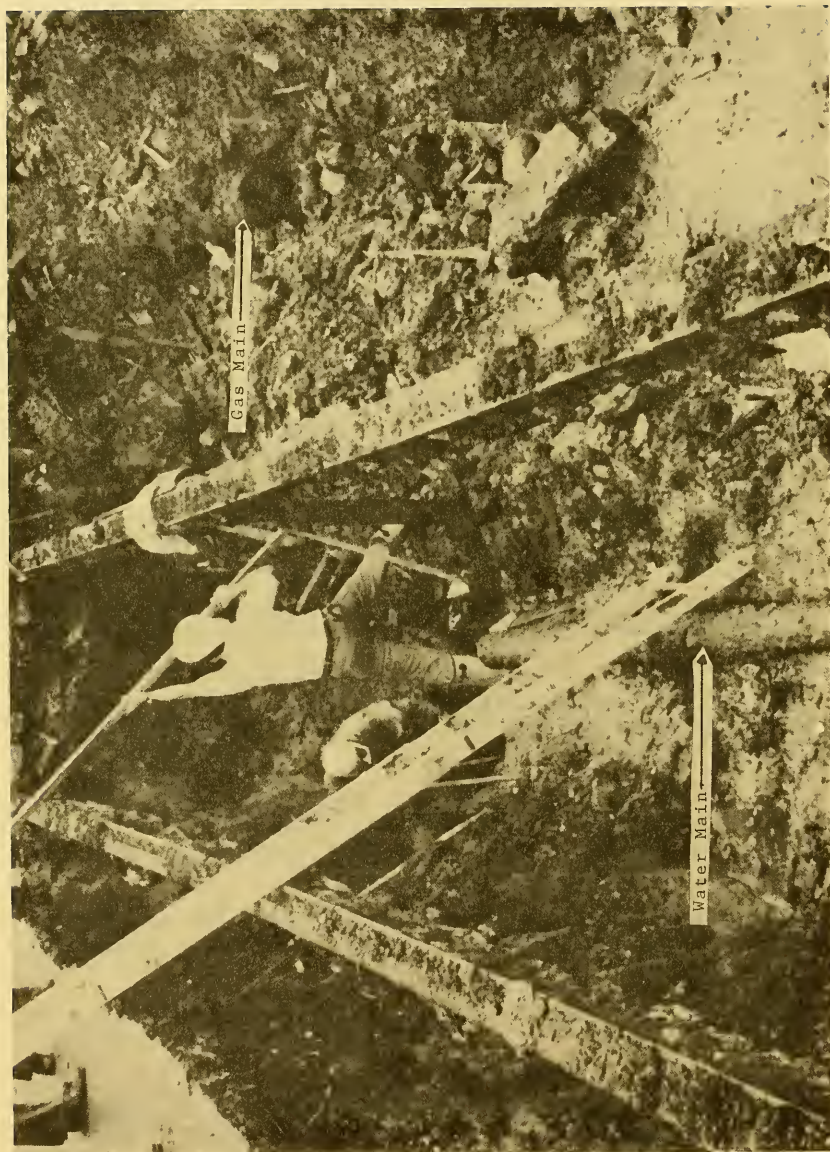
3. The cavity beneath the road appeared to have been in existence for a considerable time before the road collapsed. The trolley track apparently had supported the road surface and all the vehicular traffic on the road up to the time of the cave-in. (See figure 8.)

Figure 8. Partial view of cavern over which trolley track had supported pavement.

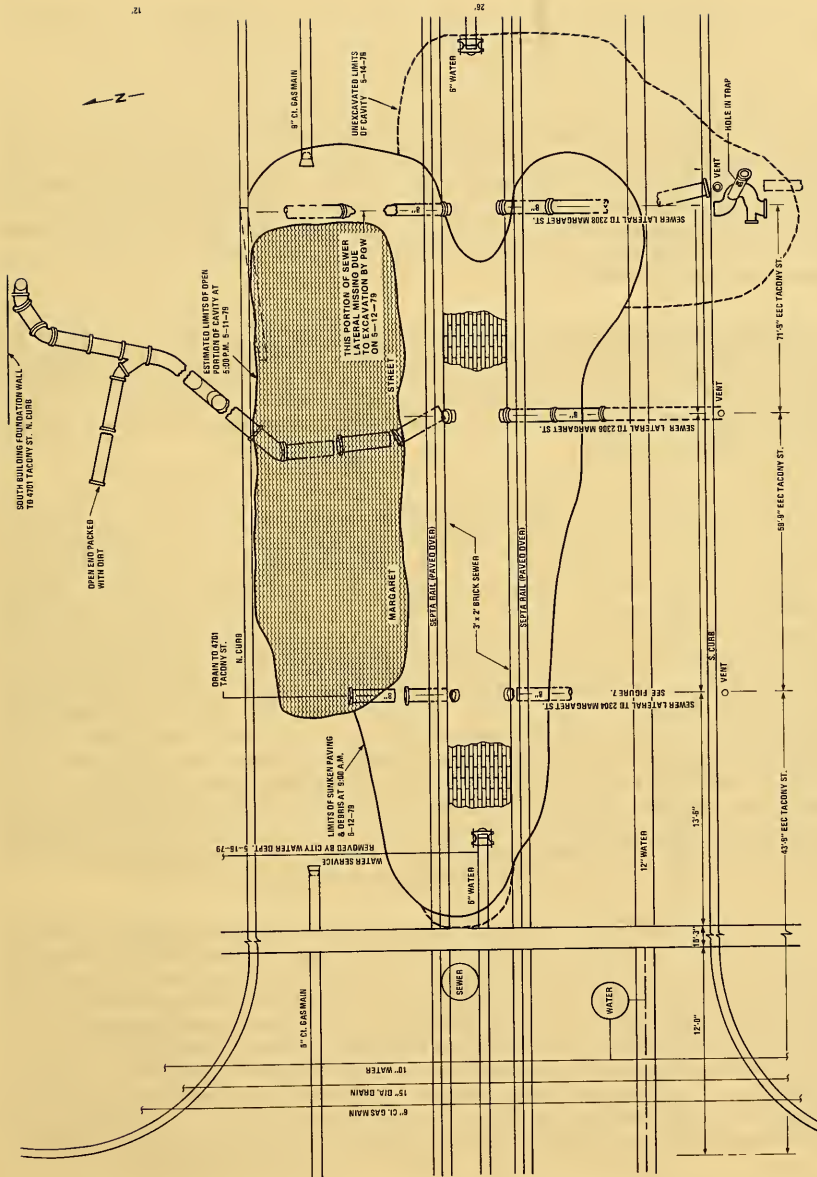
6. Six sanitary sewer laterals were excavated and examined. These laterals served the rowhouses and tavern adjacent to the cave-in. In general, the laterals were not in good condition; three of them appeared to have been disconnected from the sewer main for some time. (See figure 9). The ground around these laterals contained sewer sludge.

Figure 9. Plan view of initial cave-in with adjacent damaged sanitary sewer laterals.

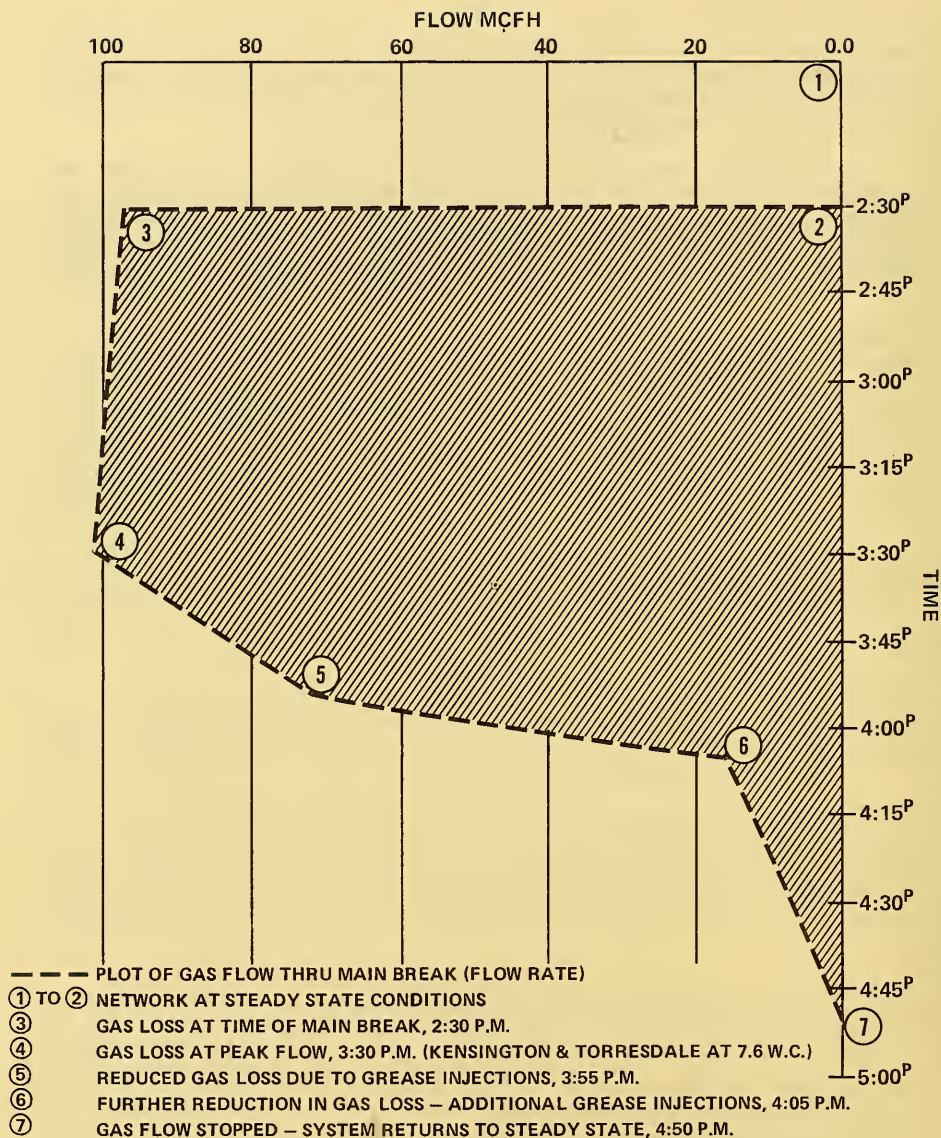
Figure 10. Time-flow plot of gas loss.

Calculations of gas loss. — Computerized calculation of gas flow showed a total of 152.76 MCF <sup>2/</sup> of gas lost from 2:30 p.m. to 4:50 p.m. (See appendix B.) From 2:30 p.m., the time of the failure, until 3:05 p.m., the time of the explosion, a total of 50 MCF of gas entered the cavity beneath the street. It took approximately 3 minutes to fill the estimated 4,780-cubic-foot cavern at a rate of 1,619 cubic feet per minute.

TOTAL GAS LOSS = 152.76 MCF = CROSS HATCHED AREA UNDER CURVE OF FLOW RATE
